Application for Use of Village Property for Construction Activity

Project: 9 North Avenue Northport ME

9 North Avenue, Northport, Maine: Dangerous Building Assessment
Project 2023-0059

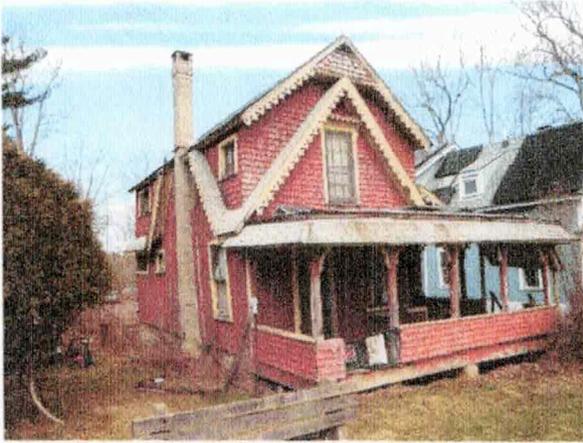
- The existing building is in a state of disrepair and non-conformance.
- The building is unsafe to access.
- The front/south porch roof is tarped. The tarp is loose and insufficient to keep water out of the structure.

- The front/south porch roof is structurally unsound. (2) 2x4 posts have been added (also reportedly by a neighbor), to prevent the roof from collapsing.

1) Exterior – South/west façades; south/front porch; porch has tarp roof; porch roof and floor are structurally unsound

Front porch pulled off the building and hauled off site

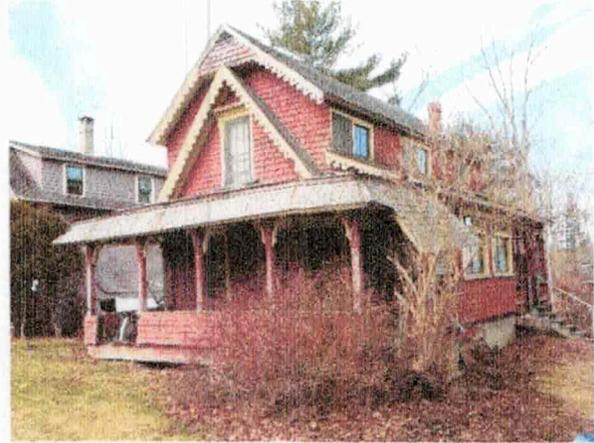
- The side entry roof on the front/south porch is failing. It is currently held up by (2) salvaged 1x3s fastened together, reportedly installed by a neighbor.

2) Exterior – South/east façades; south/front porch; extended overhanging entry porch roof is failing; porch is structurally unsound

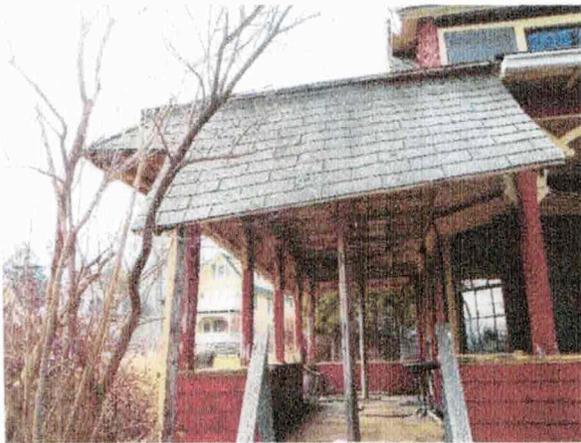
3) Exterior – South/front porch extended overhanging entry porch roof is failing

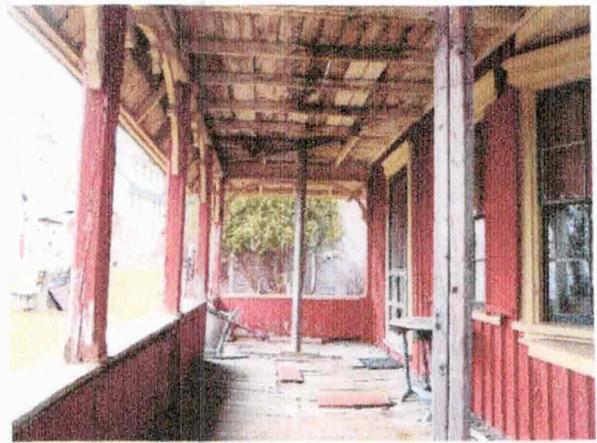
- The front/south porch floor is degraded and unsafe. The new posts installed to prevent porch roof collapse are causing depressions in the porch floor deck.

4) Exterior – South/front porch roof and floor are structurally unsound

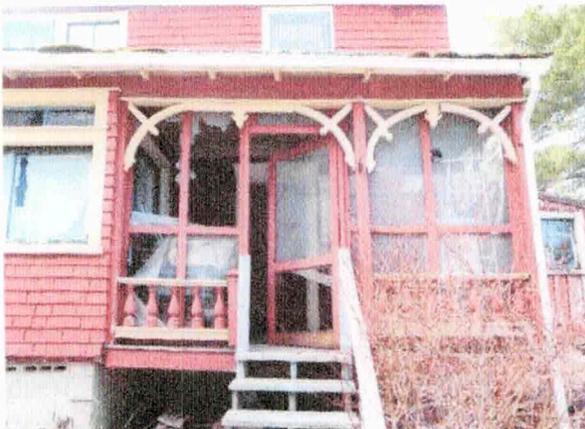
- The porch at the northeast corner is degraded and failing. One of the posts is not providing support. The porch floor appears to be sinking/collapsing. The porch is unsafe.

5) Exterior – Northeast porch roof and floor are structurally unsound

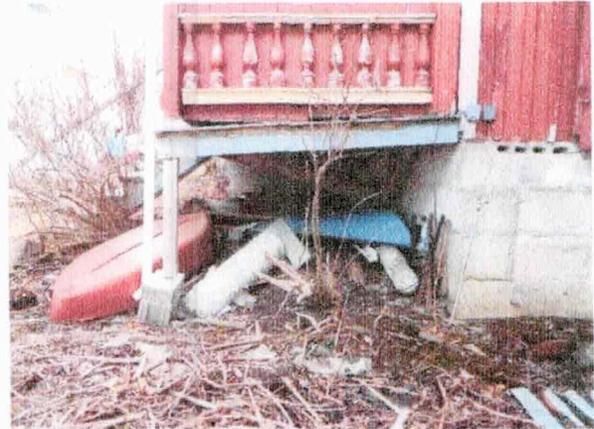
6) Exterior – Northeast corner of northeast porch lacks support; blocks are toppling over (not touching post); floor is deflecting downward

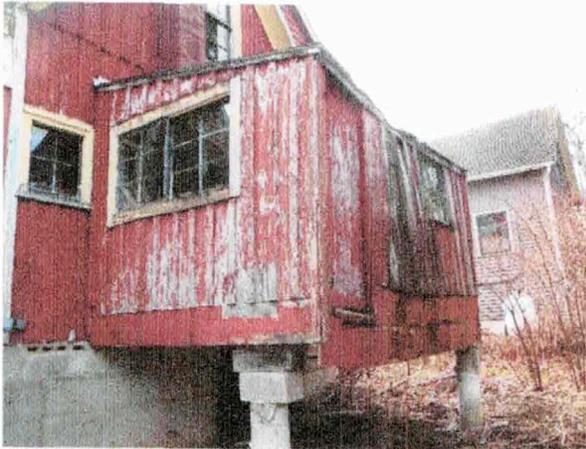
- The rear/north addition lacks proper structural support and integrity. The addition is separating from the main building, with large gaps present between the two. The ledger at the floor level is close to slipping off the foundation shelf. Any fasteners from the ledger to the main house floor system have likely pulled out and/or lack adequate penetration to transfer loads. The rear/north addition is at risk of collapsing.

7) Exterior – North addition is degraded and appears structurally unsound

Rear shed removed and hauled off site

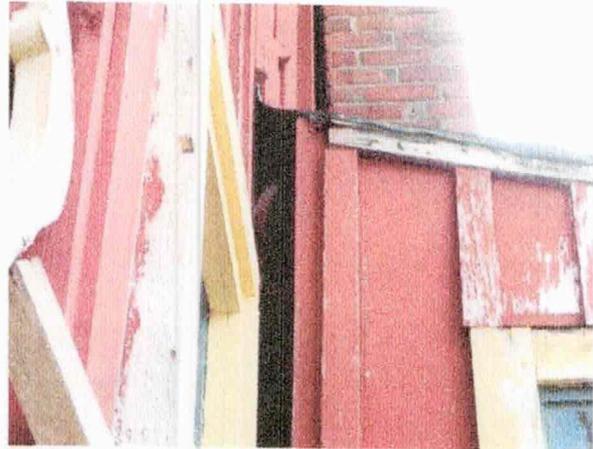
- The rear/north addition has a chimney which is visible above the roof, but does not continue down to the foundation. It is surmised that the masonry chimney bears on the addition floor framing which is combustible (wood).
- The chimney on the west exterior wall is in disrepair. Spalling and cracks are visible.
- The wastewater line is disconnected under the front porch, suggesting the home has been abandoned for some time; or if occupied, has been depositing wastewater directly into the ground under the front porch.
- The building has not been maintained, is dilapidated and is in the process of slowly collapsing.
- Exterior trim and finishes are degraded.
- Some windows are broken, leaving the building open to weather.

8) Exterior – North addition is separating from the main house; the chimney visible above the addition roof bears on combustible framing

Rear chimney tor down and hauled off site

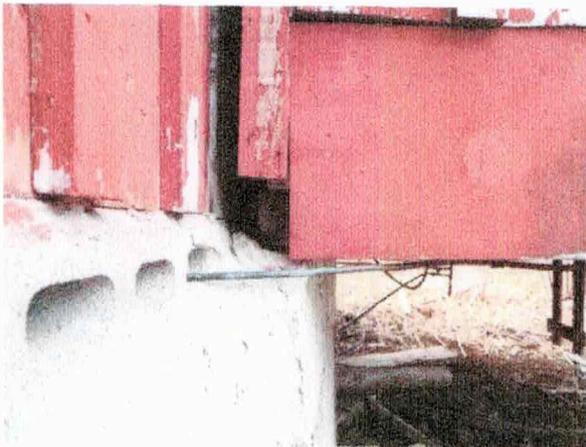
9) Exterior – North addition is separating from the main house

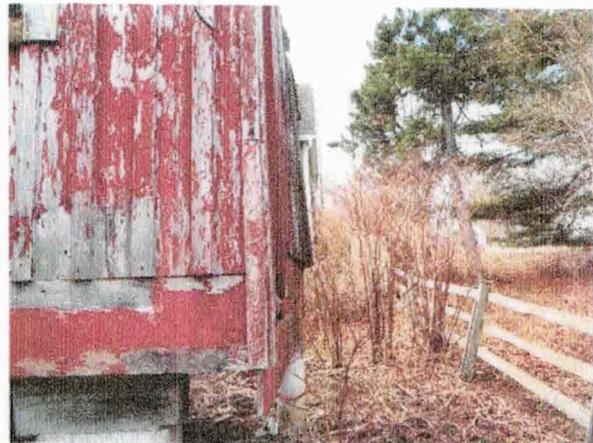
- There are significant bulges in the rear/north addition walls, suggesting structural failure within the walls.
- The foundation is discontinuous and is failing in multiple locations. CMU blocks are loose and out of plane. Some blocks have dislodged. Large, structurally significant, cracks are present in numerous locations around the foundation. The sill is partially off the foundation in some locations.

10) Exterior – North addition has significant bulges in the exterior walls, suggesting structural failure in the wood framed walls

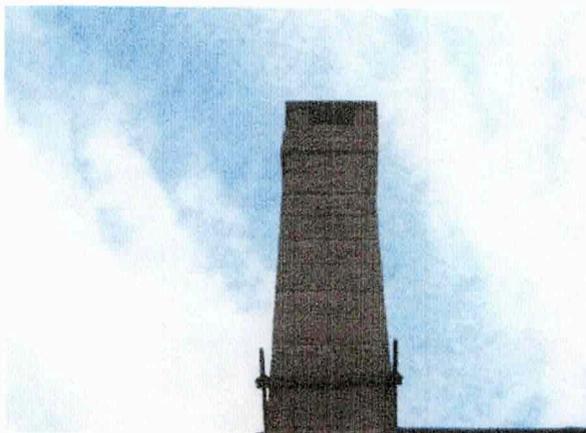
11) Exterior – West CMU chimney has significant cracks and may be unstable above the roof line

Exterior block chimney tore down and hauled off site

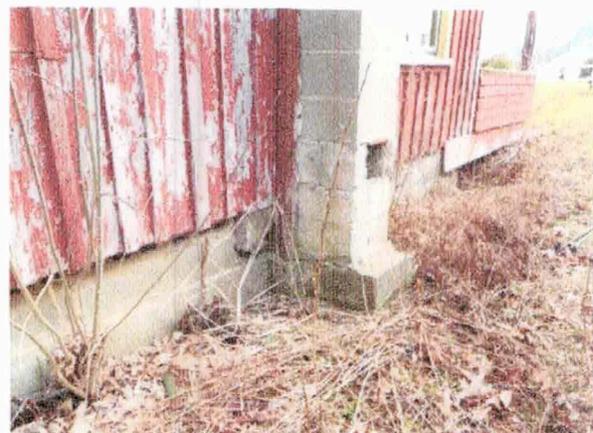
12) Exterior – West CMU chimney has significant cracks and spalling at the base

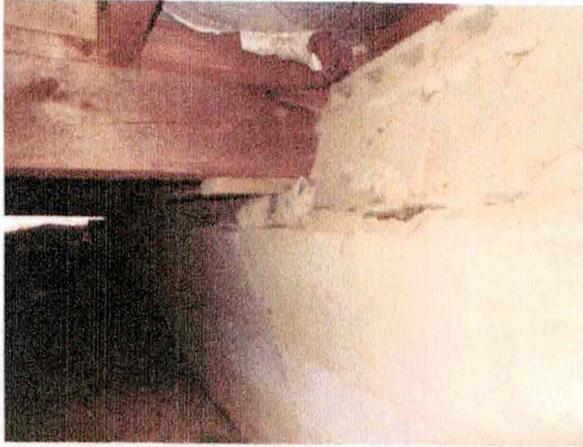
13) Foundation – CMU block courses are tipping, rotating and otherwise failing; large cracks and displaced blocks are present

West side damaged wall: dig exterior wall, haul material off site, replace with crushed stone backfill, place drain pipe. Attempt to repair wall. If repair is possible: drill and pin to anchor to wall with rebar, add vertical and horizontal rebar for structural strength, add new concrete footing/wall attached to the original wall. If the wall can not be repaired I will pull the wall from underneath and replace with a new wall. The new wall will consist of 8 inch ICF with structural strength as needed.

Proper crushed stone backfill and positive drain around the remaining three sides of the building

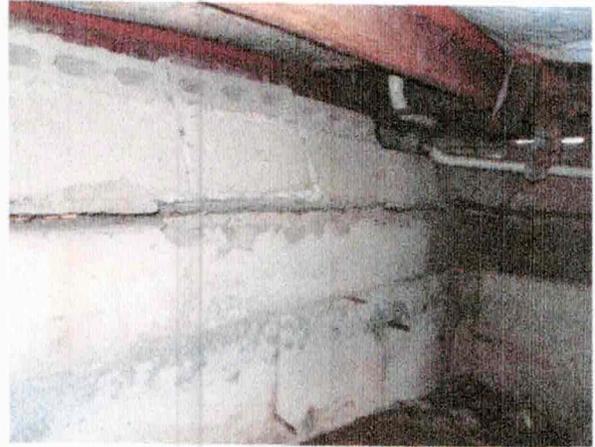
14) Foundation – CMU block courses are tipping, rotating and otherwise failing; large cracks and displaced blocks are present

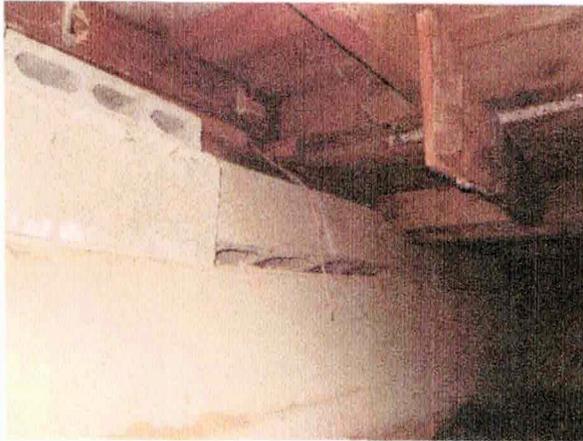
15) Foundation – CMU block courses are tipping, rotating and otherwise failing; large cracks and displaced blocks are present

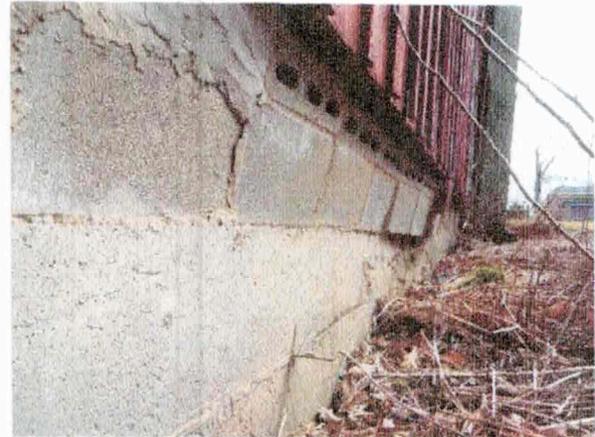
16) Foundation – CMU block courses are tipping, rotating and otherwise failing; large cracks and displaced blocks are present

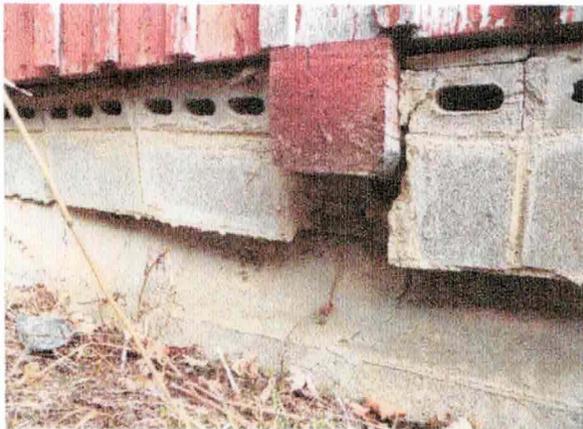
17) Foundation – CMU block courses are tipping, rotating and otherwise failing; large cracks and displaced blocks are present

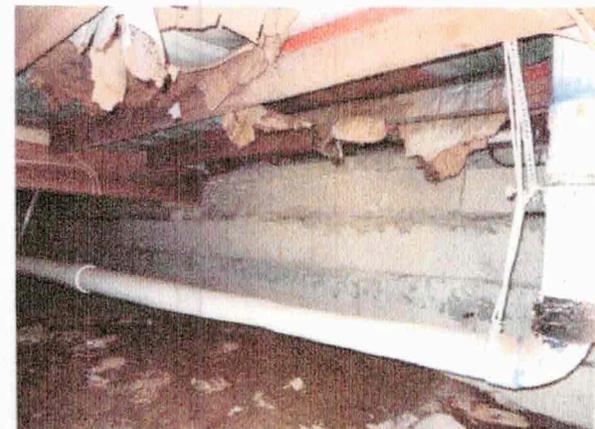
18) Utilities – Main wastewater line runs southerly from north addition to south/front porch where it is disconnected and ends on the ground
