**Northport Village Corporation  
Village Agent Report  
July 14, 2024 Board of Overseers Meeting**

Attachment: June 21, 2024, Pinnacle Hill Engineering 2024 Annual Inspection of Wharf at Bayside

Re: 2024 Annual Inspection of Wharf at Bayside

This letter report contains the results of the annual inspection of the Bayside wharf.

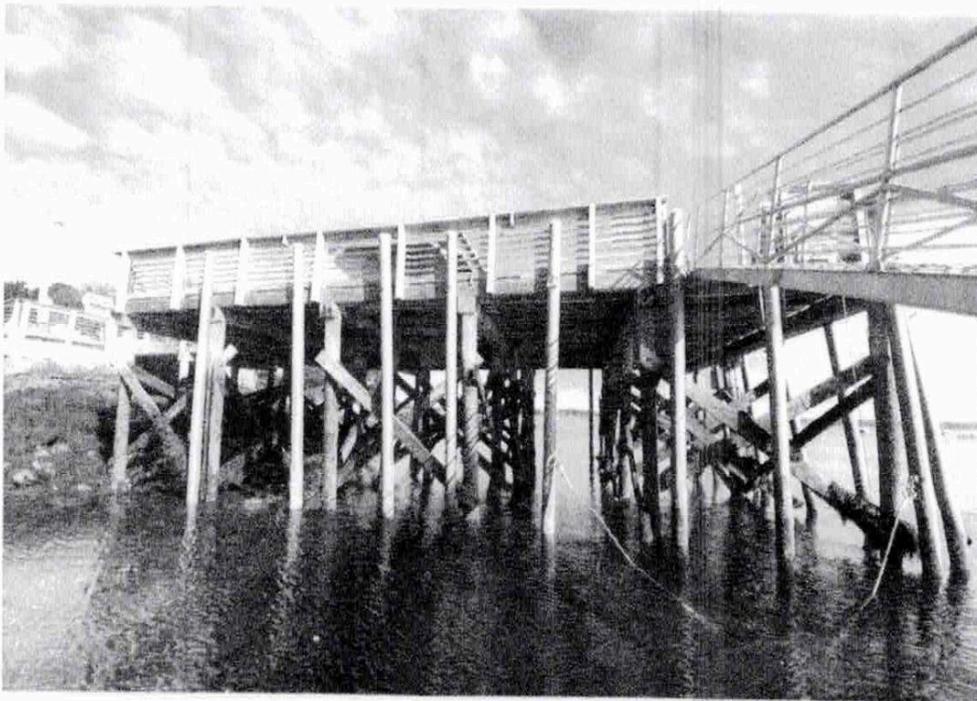
Bayside Wharf Inspection 2024

Based on this inspection it appears that the pier is still in good condition but the stresses of the recent winter storms have damaged a lot of the bracing under the deck and between the piles. The number of bracing members that appear to be unsound is substantial, approximately 12 braces should be completely replaced this summer, with new timber, new bolts, dock washers and zinc cap nuts. There are other braces where the bolt holes are

enlarged and the bolts and washers should be replaced. As part of this process the NVC should pressure wash the bracing throughout, especially the lower ends of the braces, to expose the timber surfaces and see if more cracks and split damage is concealed by the marine growth on the surfaces. Additional damaged braces may be visible once the surfaces are cleaned.

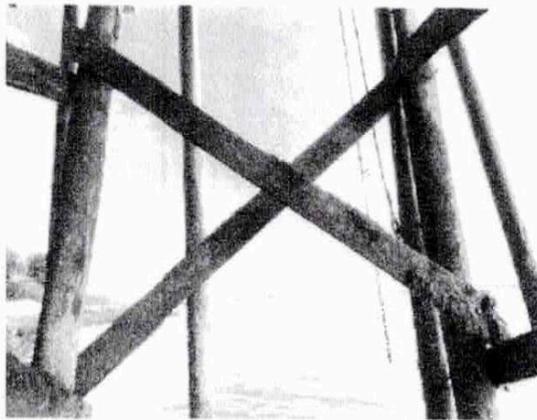
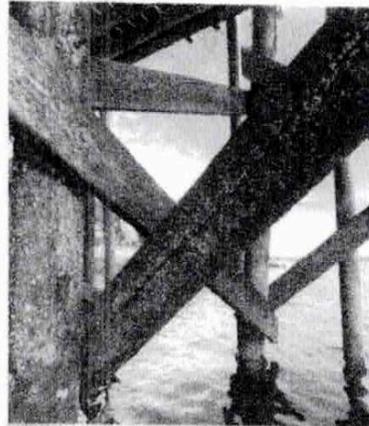
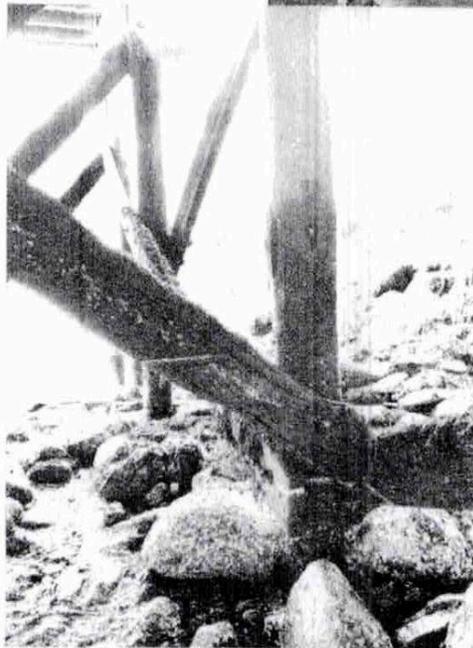
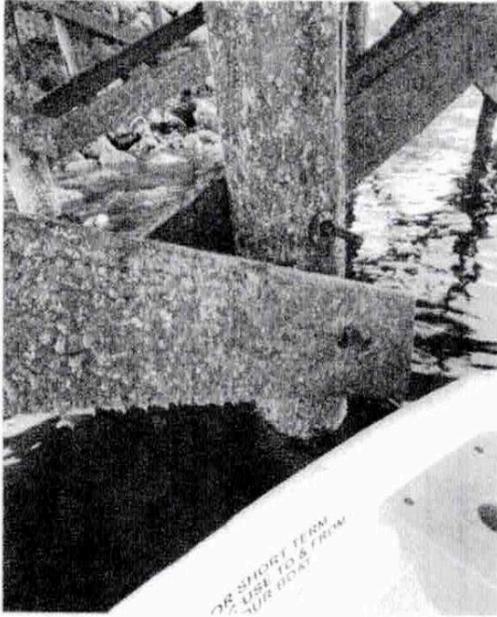
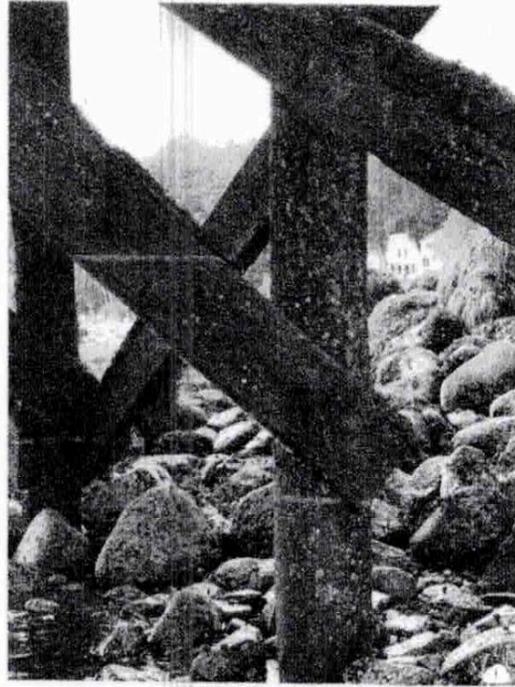
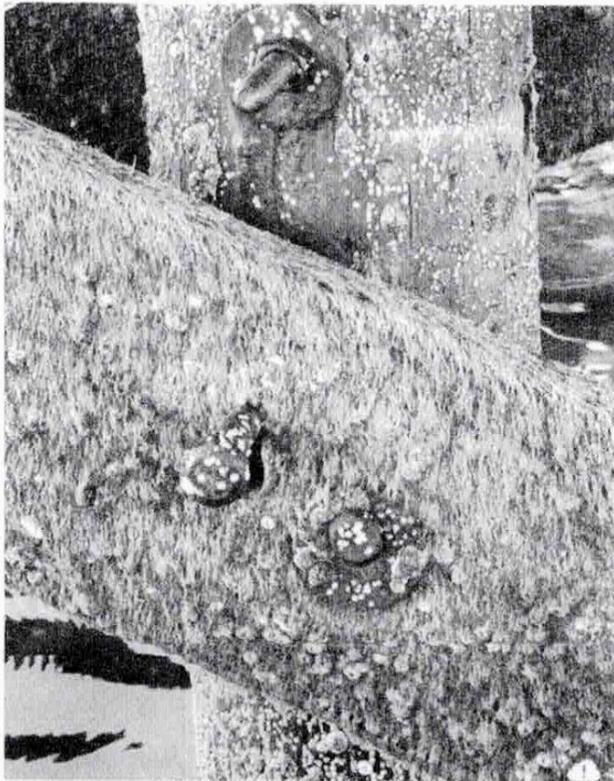
- In recent years the main problems have been deterioration of the X-bracing under the pier, with a few problems with braces each year. This year I saw many more weakened braces than prior years. The braces have splitting probably caused by the strain imposed by the December 2023 and January 2024 storms, which caused extensive damage to piers throughout the Maine coast. Three different times there were high winds and waves that occurred simultaneously with extreme astronomical high tides. The resulting tide levels were much higher than historically occur, so that the typical pier decks were submerged and battered by waves for upwards to an hour. Those conditions were enough to tear apart many timber pier structures that had been previously adequate.

- In past years we have been noting split braces for immediate replacement and also pointing out the ones with checks and cracking that seemed to be candidates for the next couple of years. Some braces develop deep checks, usually near the bottom ends - two were noted last year to be replaced in the next couple of years. However that pattern has been broken and this year the splitting and checks seem to be present in many more braces than normal. I attribute this to the storms, which stressed to bracing much more than normal. I noted a total of 12 braces to replace that I could see, including the E5 brace further described below. These are shown on the attached plan. The photos below show some of the cracked braces

- Given the high number of visible cracks I recommend that all bracing should be considered to potentially have concealed damage and that you should engage a high pressure water blast cleaning of the bracing in order to remove weed growth, barnacles, and slime and better expose the wood surfaces. I believe that this will reveal some additional damage that is not now visible.

- Replace bracing with new 3x10 Southern Pine pressure treated to 2.5 pcf with CCA preservative. This treated lumber preservative is only sold by lumber yards for Marine use. Viking Lumber in Belfast is one of the primary suppliers for this material. Other species and pressure treatments may look outwardly the same but are not adequate for marine submergence applications.

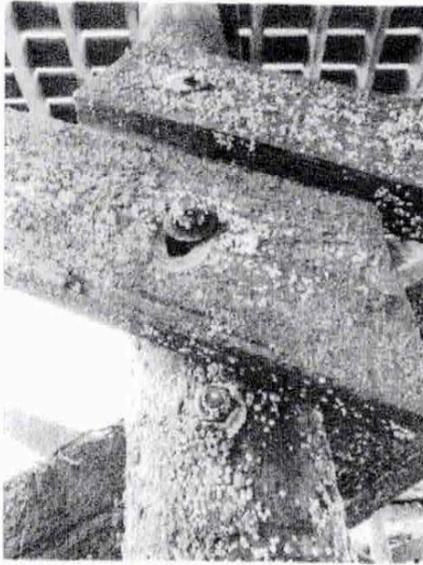
- One brace came free and is hanging vertically from a bolt on Pile E5. This brace was recommended to be replaced last year but that was not done. The brace was a repair of previous damage and the bracing members were long planks spanning two pile spaces for piles C5,D5 and E5. Over the years the repairs have resulted in haphazard

2023 report brace recommended to be replaced

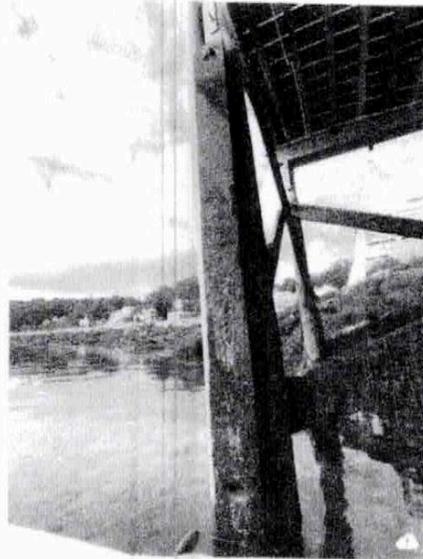
2024 that has failed, pile E5

replacement of the two long diagonals originally there, so now the three piles are not braced properly. I recommend that you reconfigure those two bays to have one "X" on each bay rather than the current pattern. The current piece of bracing is hanging vertically should be

discarded and you should remove the other parts of the long diagonals still in place. Then install two sets of diagonals as pairs to make two "X"s. These replacement braces must be installed this year.

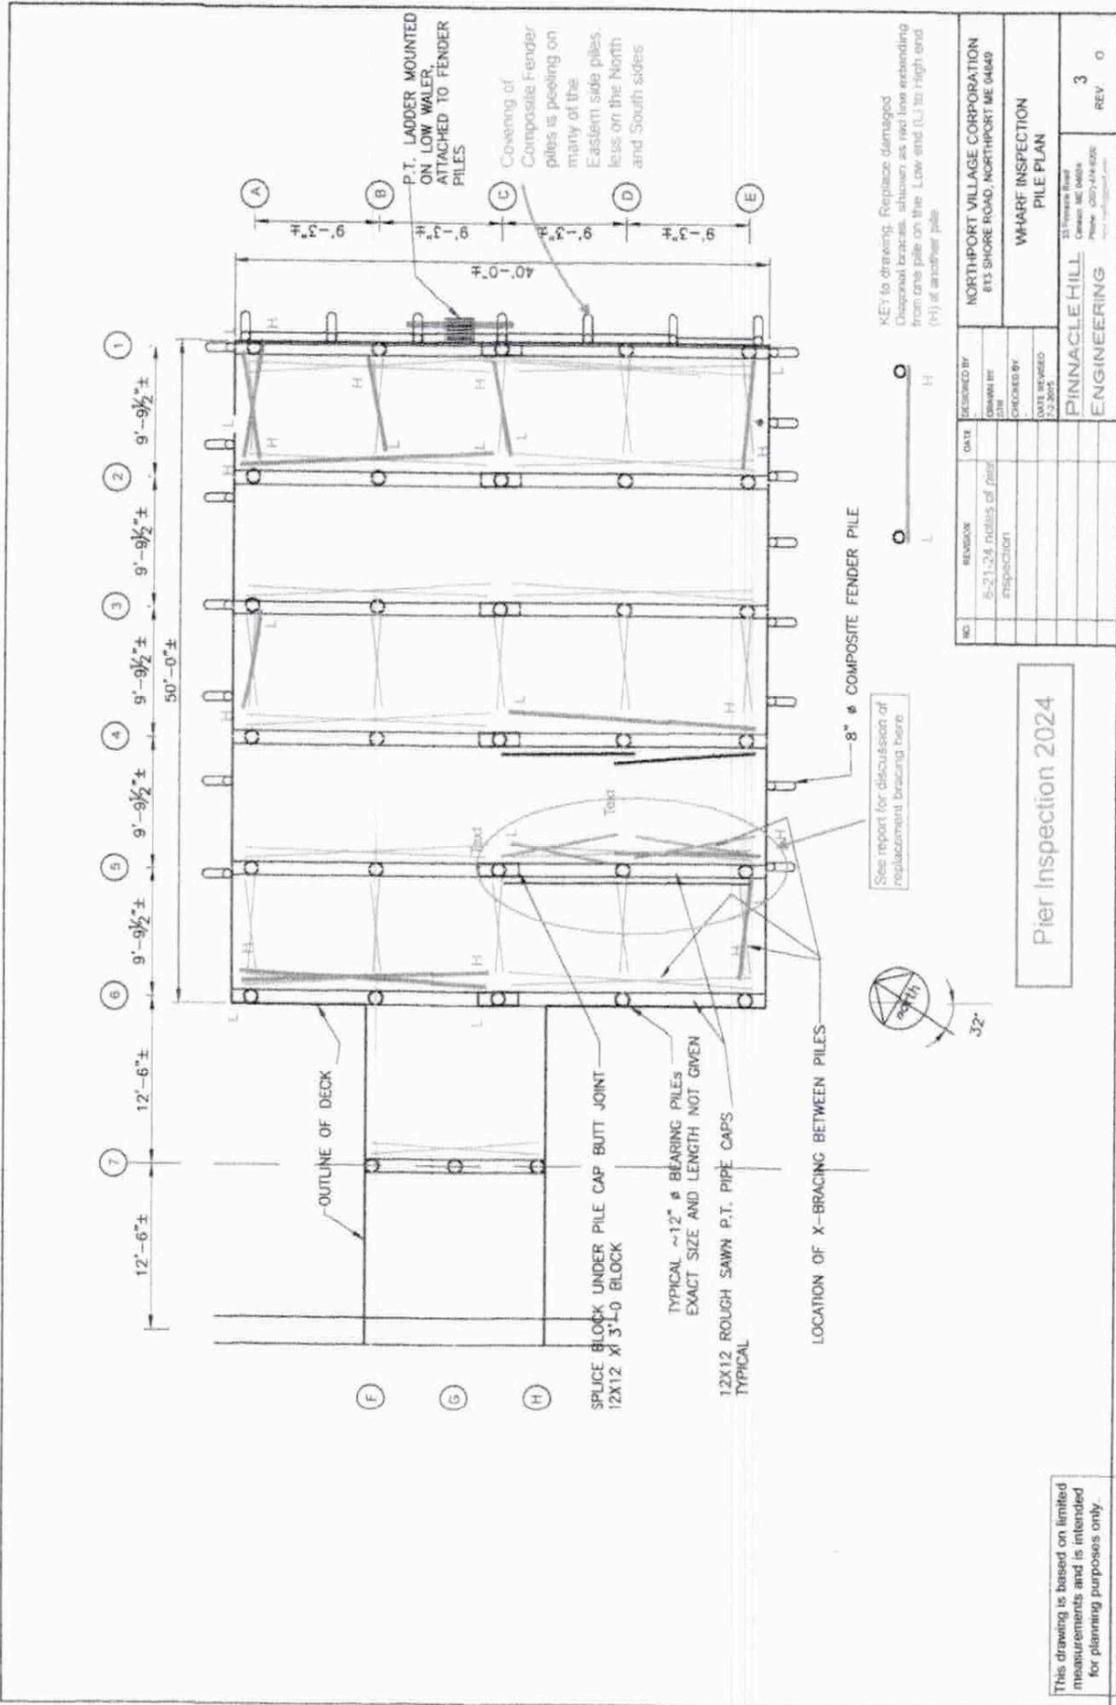
Attachment: Sheet 3

KEY to drawing: Replace damaged Diagonal bracing, shown as red line extending from one pile on the Low end (L) to high end (H) of another pile
