Application for Use of Village Property for Construction Activity

Project: 9 North Avenue Northport ME

9 North Avenue, Northport, Maine: Dangerous Building Assessment
Project 2023-0059

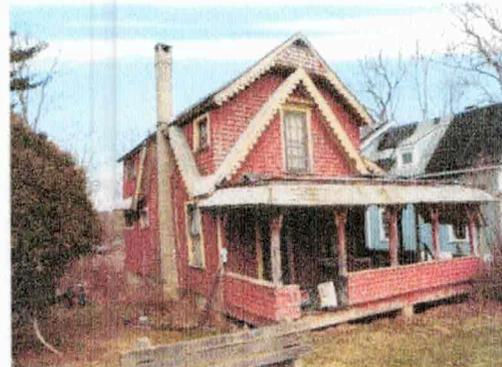
- There are significant bulges in the rear/north addition walls, suggesting structural failure within the walls.
- The foundation is discontinuous and is failing in multiple locations. CMU blocks are loose and out of plane. Some blocks have dislodged. Large, structurally significant, cracks are present in numerous locations around the foundation. The sill is partially off the foundation in some locations.
