**Northport Village Corporation  
Village Agent Report  
July 14, 2024 Board of Overseers Meeting**

Attachment: June 21, 2024, Pinnacle Hill Engineering 2024 Annual Inspection of Wharf at Bayside

Re: 2024 Annual Inspection of Wharf at Bayside

This letter report contains the results of the annual inspection of the Bayside wharf.

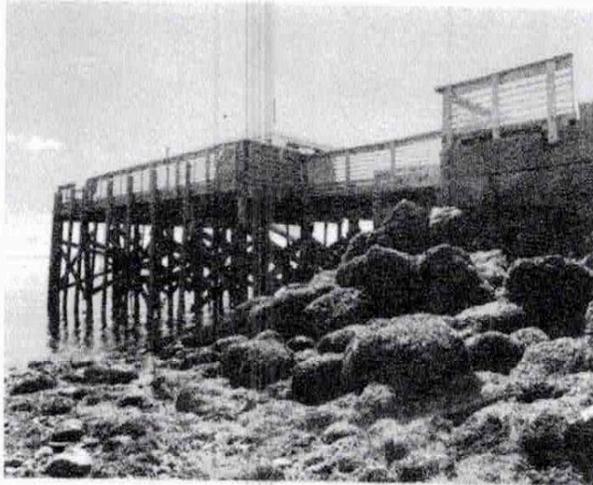
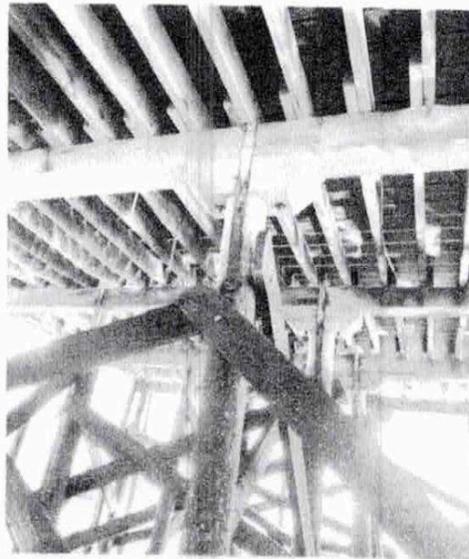
- The Bayside pier seems to have done well comparatively. I attribute that primarily to the fact that your pile caps are connected to the piles with steel straps and bolted connections, rather than the more typical connection traditional in Maine piers, which is a driven steel pin through the pile cap into the top end of the pile. Those connections do not have a lot of resistance to uplift, and did not fare well. The pins pulled out of the piles, and allowed the decks to lift upward, sometimes with complete failure of the pier. I have viewed the video of the Town of Lincolnville Fish Pier which had some straps and some pinned

connections. In the video the water was over the deck and the waves lifted and dropped the wood deck structure, flexing it like a snake for a period of time. I was there following the storm and we saw that the pinned connections in the center of the pier deck had lifted up some but held their alignment, so the deck could settle back down. The outer perimeter piles of the pier have steel strap connections, which appears to have been enough to hold the structure together for the time needed. I inspected several other piers that had the deck lifted high enough that the pins came out of the holes and the pins bent so that the pier deck could not return to the original position.

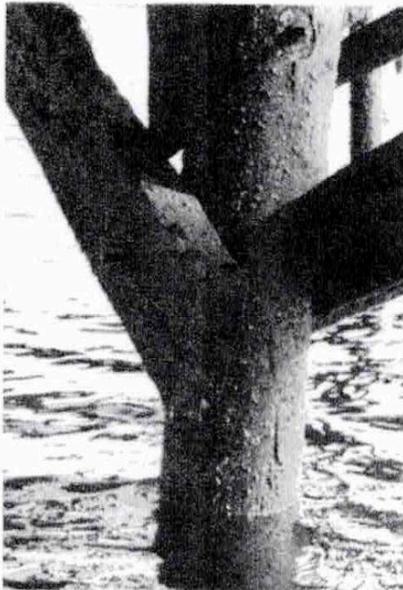
- Do not allow any loose bolted connections that will allow motion of the brace in wave action, as that will wear out the bolts hole at both ends and destroys the effectiveness of the braces. Spike grids would improve the performance of the bolted connections. I believe that this pier originally had spike grids in the joints but they have not been used recently.

•New Bolts should be installed for all repairs, all bolts should be upsized to 1" hot dipped galvanized hex bolts with dock washers or heavy galvanized square plate (3/8" thick or more) washers. The thin standard round washers are not good enough and should not be used. They corrode so quickly that they soon leave the bolts loose and start to wear out the wood.

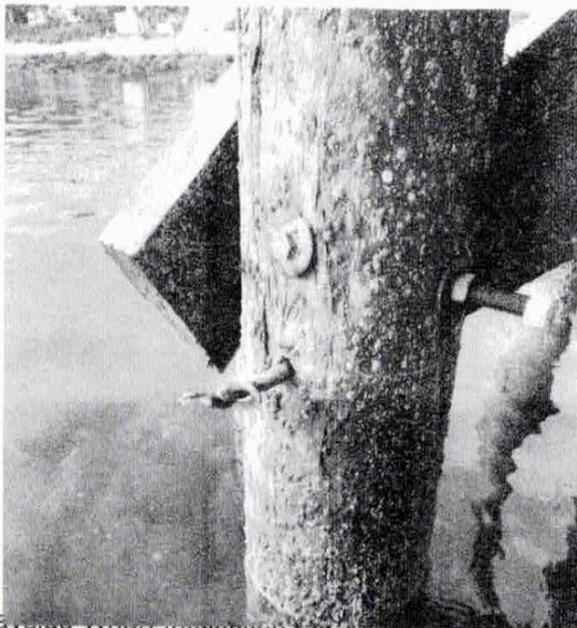
•The bolt holes through the piles need attention if they are oval shape. Re-drilling and using a 1" or 1 1/4" bolt, larger than the original, can restore a round hole. This is much preferable to drilling a second new hole. New holes should be added in new

locations away from the original bolts only if the existing holes are too large and beyond salvaging. Enlarging the bolt size should be enough for most of them, particularly if it is done early before they fail or start moving and enlarge the hole in the wood.

• Many of the bolts have received zinc cap nuts as previously recommended and have proven that these bolts are corrosion free, so it is an effective strategy to extend the life of the fasteners. Protection of each bolt with a cap nut is recommended to reduce the corrosion rate and reduce maintenance. The zinc is sacrificial and should be replaced periodically, experience will tell how often. They should be installed on all bolts throughout the pier, particularly the

lowest bolts of every brace, and on the upper straps. An online source of cap nuts with some background information is <https://www.farwestcorrosion.com/mars-zinc-caps.html>. They are not generally available locally.
